Up to 90% energy savings by renovation

**A Technical Guide to the
Thermal Renovation of old buildings.**

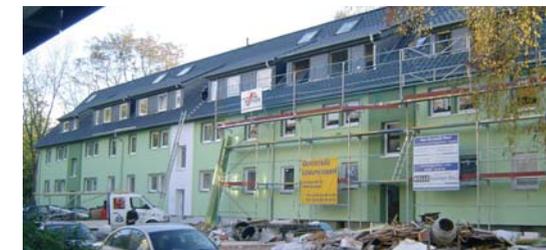
This house from the early 1950s is a typical example that you find in many housing estates of German towns. It has a living area of 1000 m², subdivided into 24 flats accessible via 6 staircases, and is located in a colony with about 30 identical ones. Its cellar and loft were not heated. Its original construction corresponds to the one described in the technical data table (as built in 1950). In 2006, it was completely renovated to a level superior even to new buildings.

The 30 cm thick brick walls received 14 cm of external insulation. The pitched roof on the 3rd floor level was opened from outside and insulated with a layer of 24 cm. The upper ceiling was opened from the top and also received an insulation layer of 24 cm thickness. The single-glazed windows with wooden frames were replaced by new wooden windows with heat-saving double glazing. In this process, in every flat two south-facing windows were enlarged. The concrete floor on the ground level was insulated from the top with a layer of 8 cm thickness. At the same time, the old wooden floor was removed that was laid with 6 cm air space between the boards and the concrete. The front and cellar doors were replaced. Mechanical ventilation was not installed. A new, highly efficient gas heating system was installed in each of those 6 flats under the roof that are located above staircases. The heating demand could be reduced from about 310 kWh/m²a down to 90 kWh/m²a.

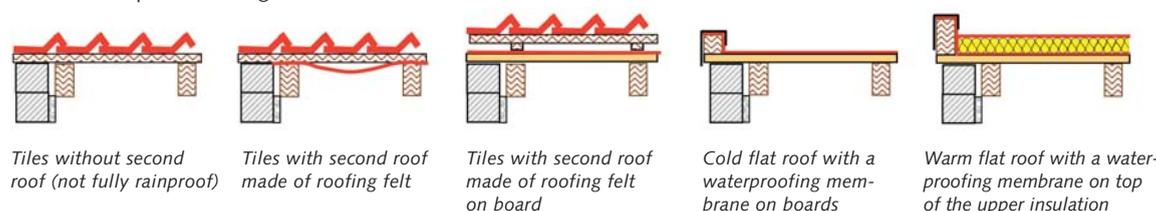
Types of coverings used on old wooden roofs

Weather protection is the most important function of a roof. Pitched roofs are primarily covered with roof tiles while flat roofs are covered with a waterproofing membrane. Many pitched roofs have a second roof under their tiles which is made of sheeting or roofing felt. In windy regions, this second roof is often fixed on boards. The following drawings show the five most frequent coverings used on old roofs.

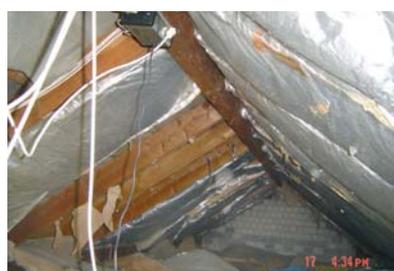
Defective aluminium-coated roof insulation and airtight layer

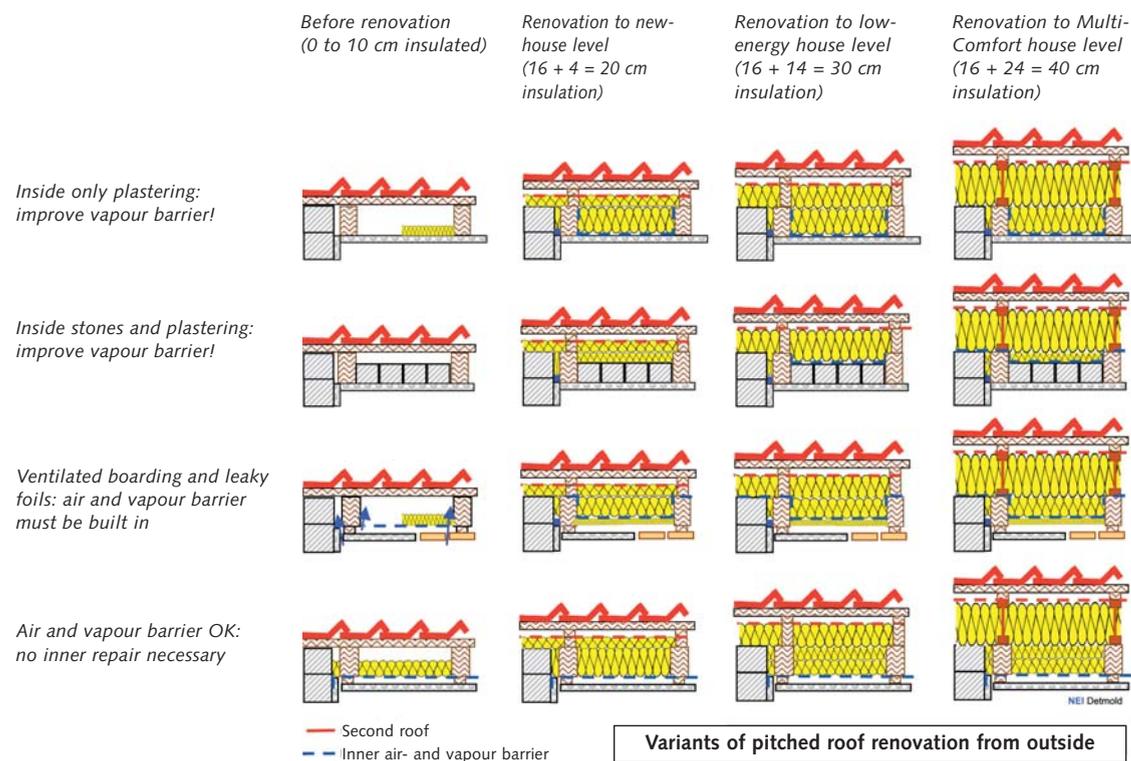
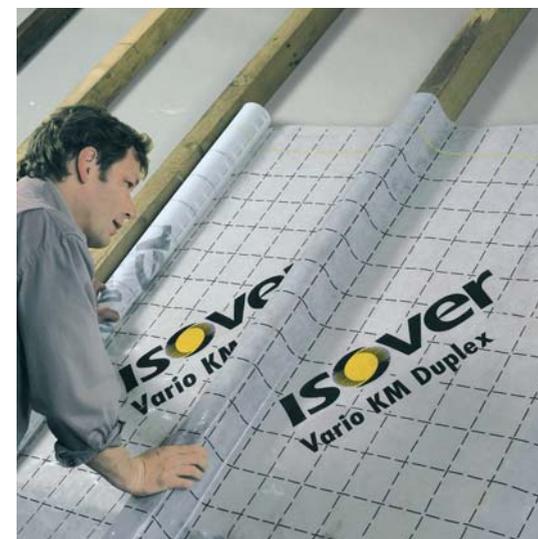
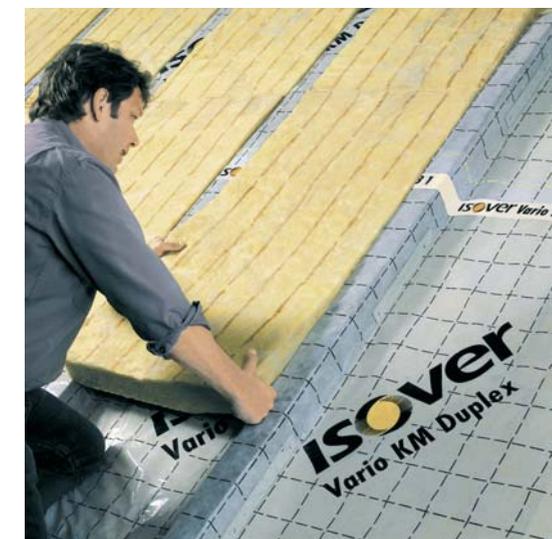
The left column shows pitched roofs before renovation as described in the previous chapter. They differ in the amount of existing insulation and the quality of inner air-sealing and vapour-retarding layers. Their outer covering is of no importance here as it will be completely removed when renovating the roof from outside. Columns 2, 3 and 4 show how these different old roofs can be improved to the level of new houses, low-energy houses and Multi-Comfort houses. To reach the roof insulation level of a new house, a 4 cm lath is fixed onto the existing 16 cm rafters and an insulation layer of 20 cm is installed. To reach low-energy house level, joists of 14 cm height are fixed on the existing rafters and a total insulation layer of 30 cm is installed. To reach Multi-Comfort or passive house level, 24 cm TJI joists are screwed on top of the rafters and a total insulation layer of 40 cm is built in.

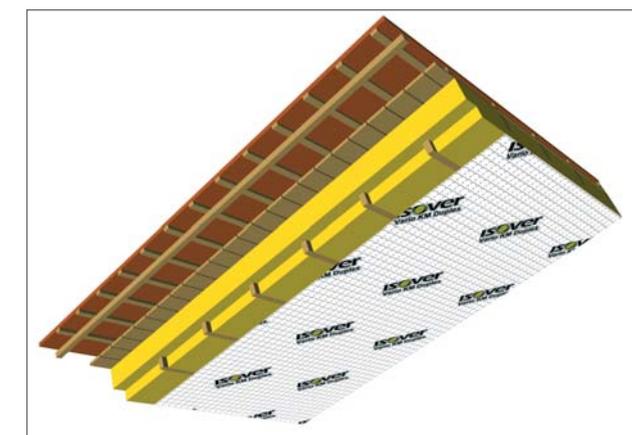
Roof insulation from inside with two additional insulation layers and a diffusion-variable membrane

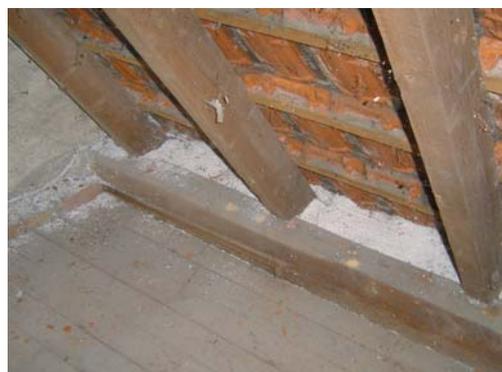
Loose granule fill between rafters made of expanded shale

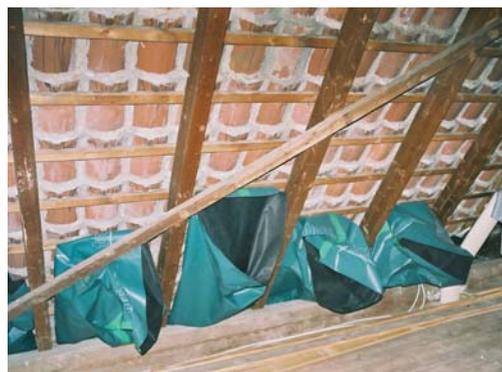
Vapour-permeable bags placed between rafters to cover later blown-in insulation

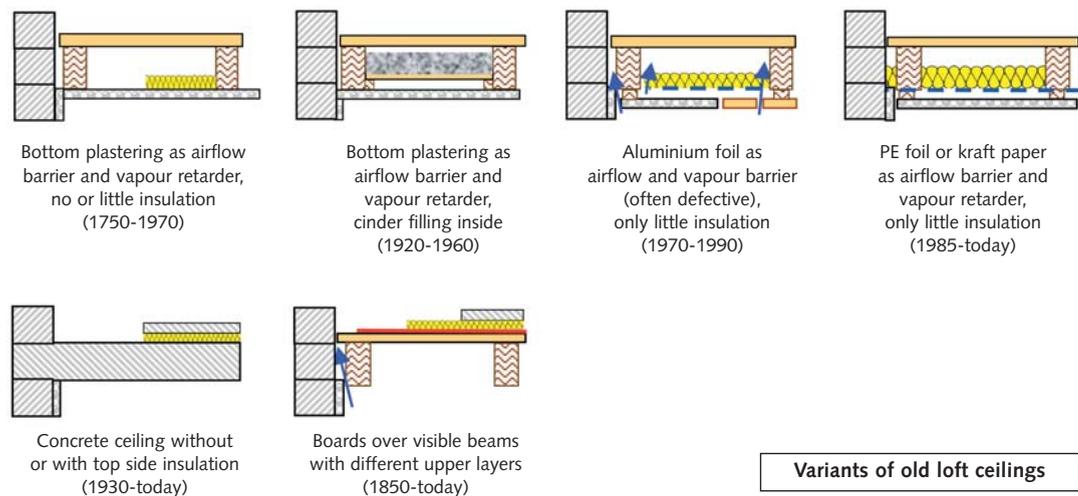
The following drawings show six variants of loft ceiling construction. They differ with respect to their airtightness and vapour-retarding quality, their usable inner space that can be filled with insulation and the level of already existing insulation. The bottom layers in the first four examples are identical with the pitched roof constructions described in the previous chapters. The fifth (a concrete construction) and the sixth (a boards-only construction with beams visible from below) are additional construction variants.

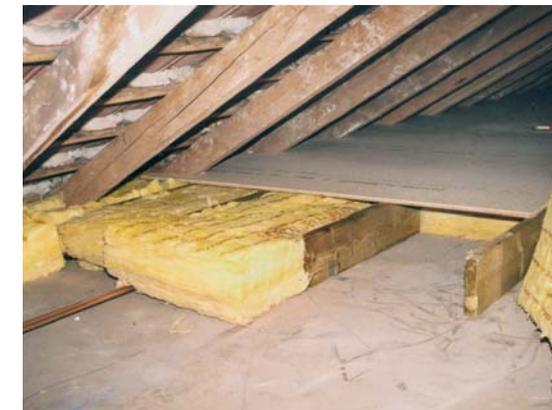
Top side mineral wool insulation and chipboard on wooden spacers

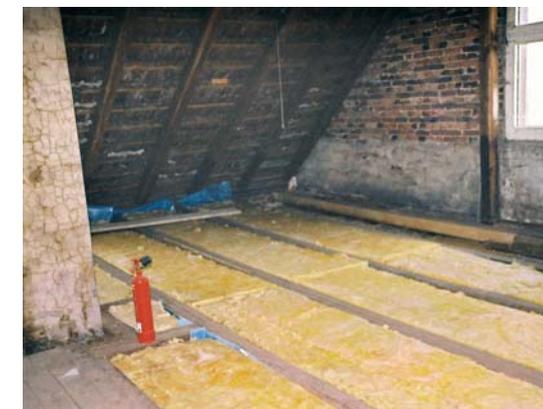
Loft ceiling opened from the top and insulated first between rafters

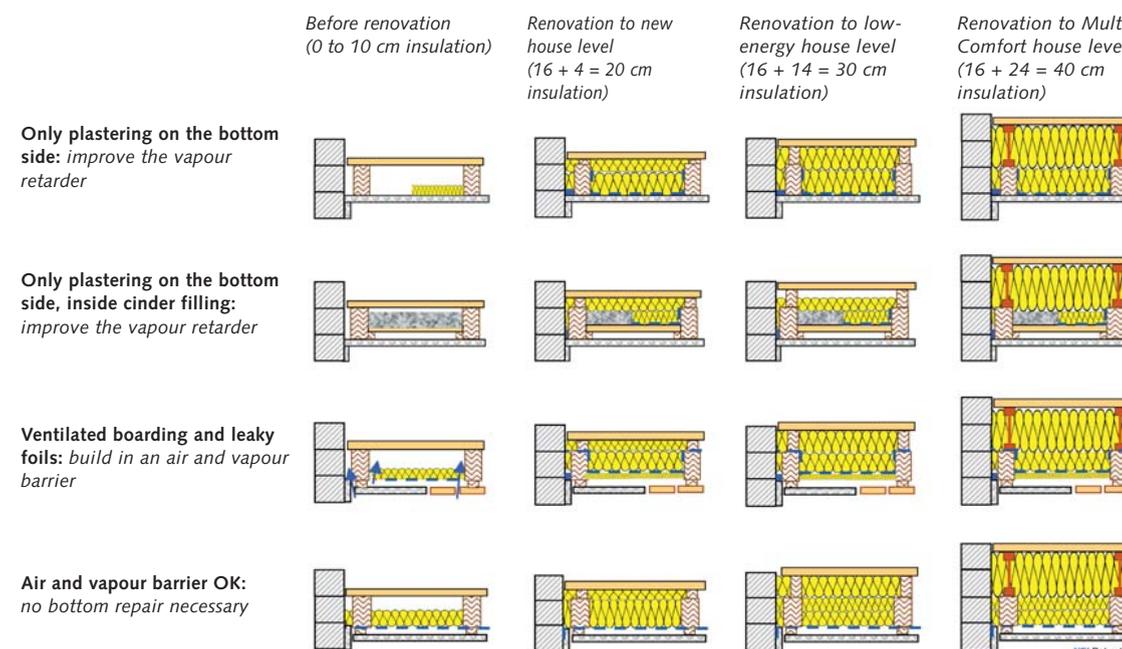
Variants of wooden loft ceilings – Renovation from the top

The drawings below show four typical loft ceiling constructions: the old condition (on the left) and three different quality levels of thermal renovation. The left column shows loft ceiling constructions before renovation. They differ in the mass of existing insulation and the quality of inner air- and vapour-retarding layers.

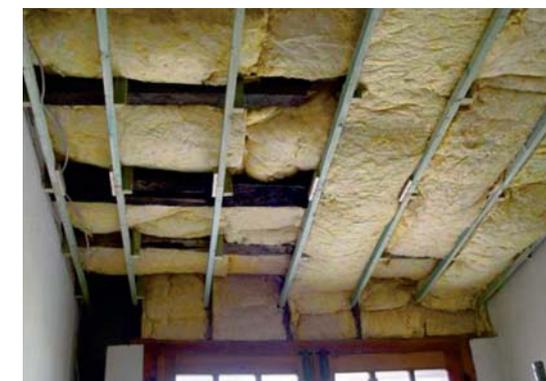
Loft ceiling insulated from the bottom: between and below the beams

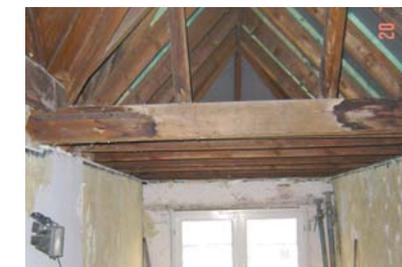
Loft ceiling opened on both sides for renovation

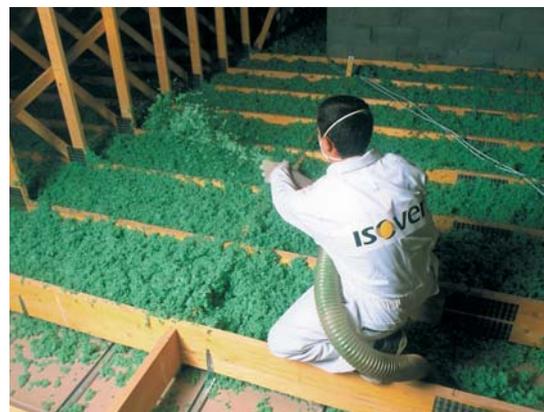
Loft ceiling opened for blowing in insulation

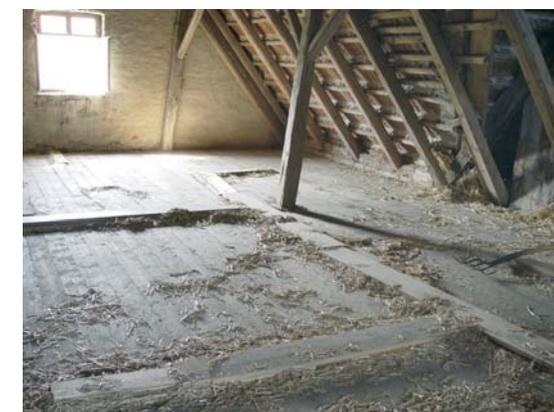
Loft ceiling only made of wooden boards – typical of old farmhouses, but now without the annually renewed straw insulation.

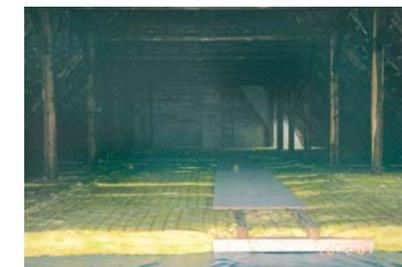
New insulation on top with an air- and vapour-tight foil underneath

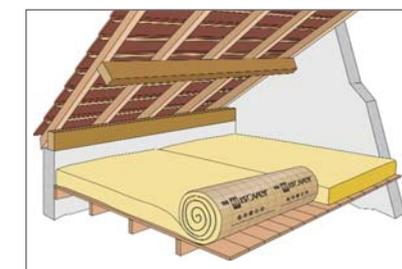
Thermal insulation of a wooden loft ceiling with beams visible from below

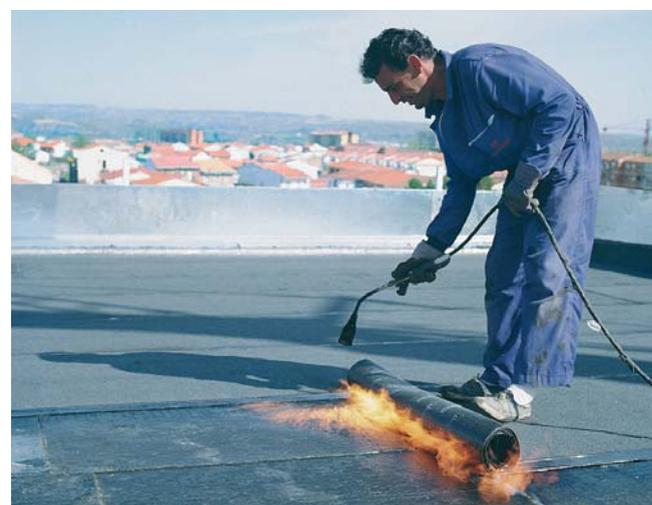
Renovation of the water-tight layer on a flat roof

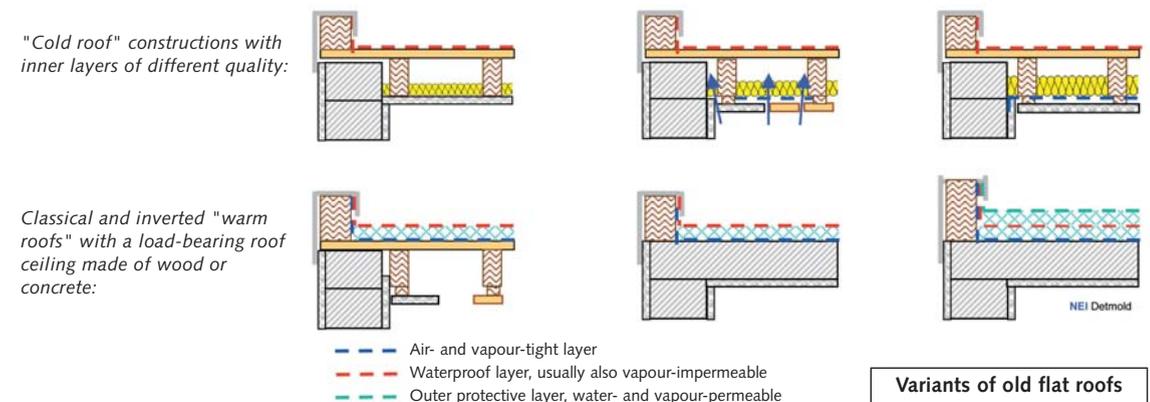
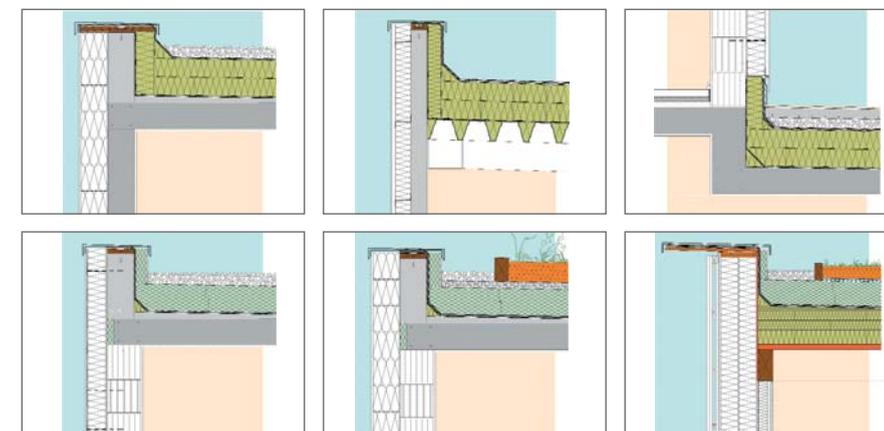
Examples of different flat roof constructions

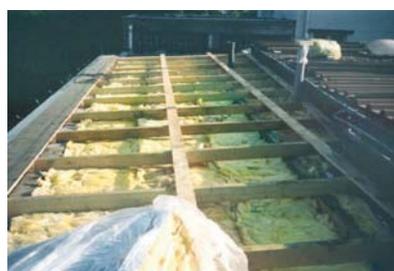
Flat cold roof opened from the top with additional joists to provide space for a total insulation layer of 24 cm thickness

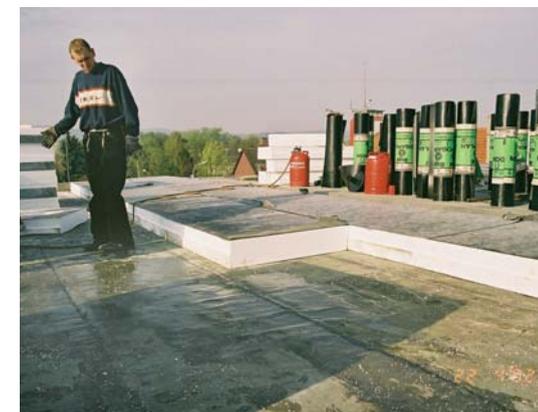
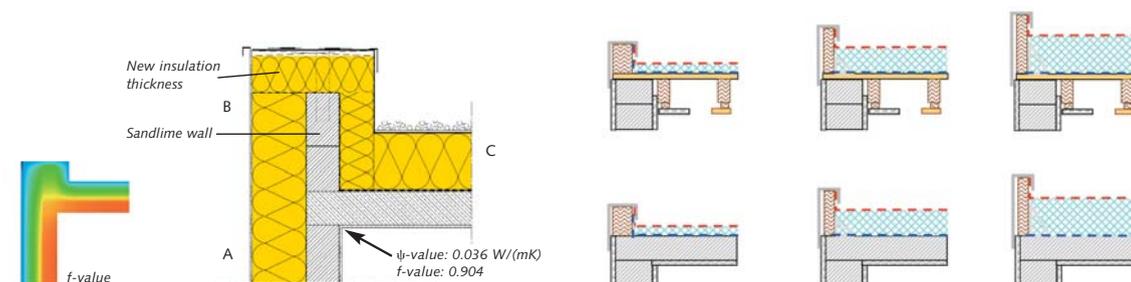
The above drawings show flat warm roofs made of wood resp. concrete with upper insulation of different thickness. The table shows the reduction of U-values, heat losses and heating costs for a flat warm roof made of wood. The calculation was based on 100 m² total roof area and heating costs of 7 eurocents/kWh for one year or 40 years of total useful life. Within this period, heating cost savings of more than 90 % – or in absolute terms 73,000 euros – can be generated if the former uninsulated roof is later upgraded to Multi-Comfort house level. The insulation layer of 40 cm thickness also guarantees maximum thermal comfort.

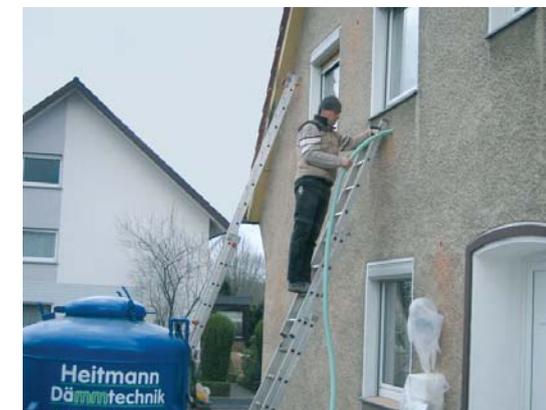
Blowing granular perlite insulation into a cavity wall

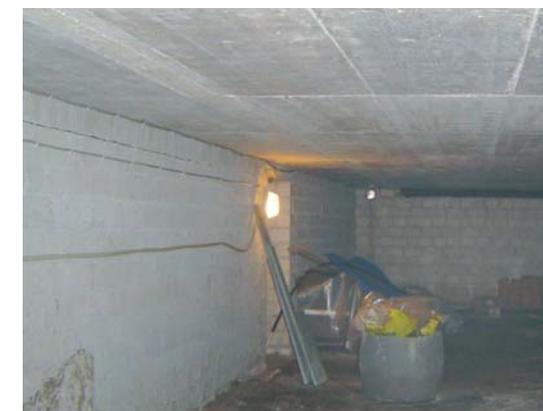
Concrete cellar ceiling without insulation. High U-value = 2.2 W/m². 10 cm insulation from below can reduce heat losses by 85 %

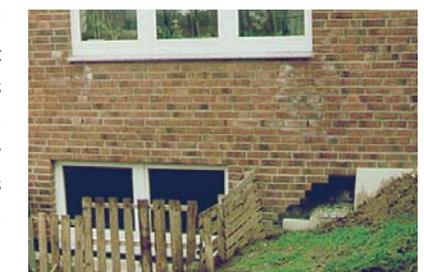
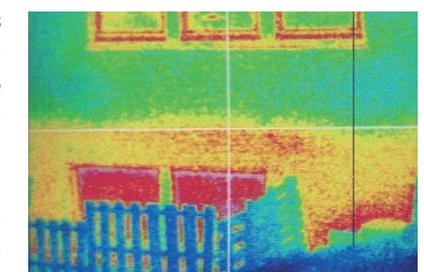
Heat losses caused by the uninsulated outer walls of a heated cellar

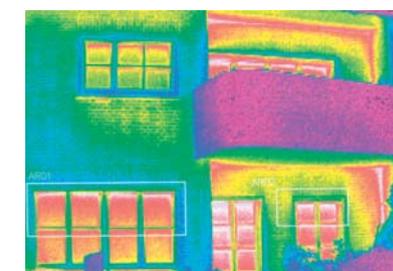
Thermography shows the higher surface temperatures near thermal bridges

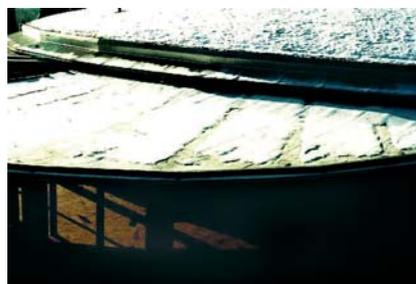
Thermal bridge caused by wooden rafters without insulation above or below

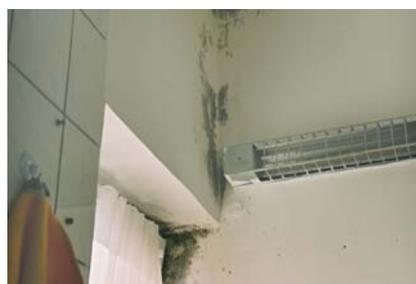
Mould in the corners of a bathroom caused by a geometrical thermal bridge to the cold outside

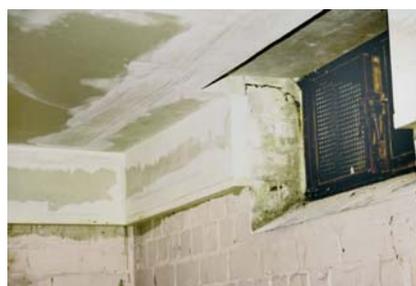
Reduced thermal bridges on a cellar ceiling by extending the insulation (6 cm thick) to the upper part of the walls (50 cm)

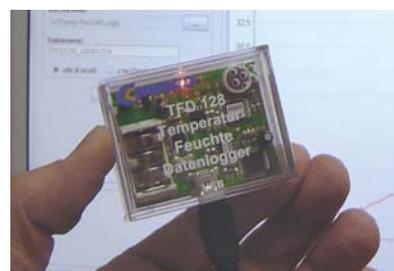
Small electronic temperature and humidity data logger with USB connection to computer

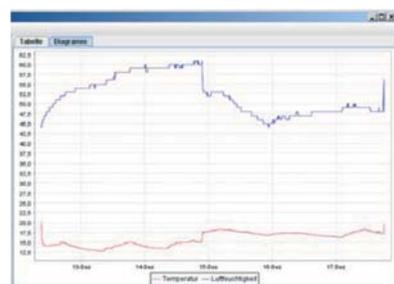
Visualized recording of temperature and moisture measurements

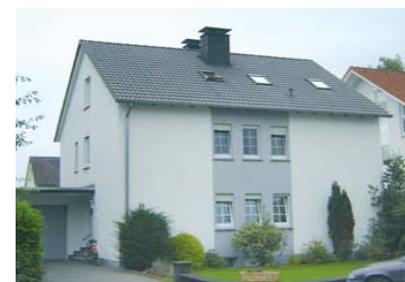
Multi-family house of the 1970s with added mechanical ventilation

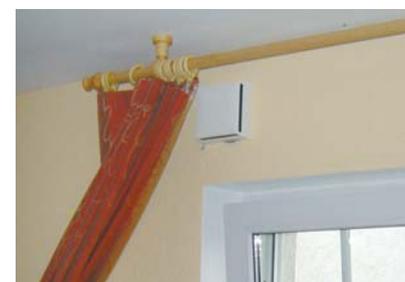
Fresh air inlet valve beside a window

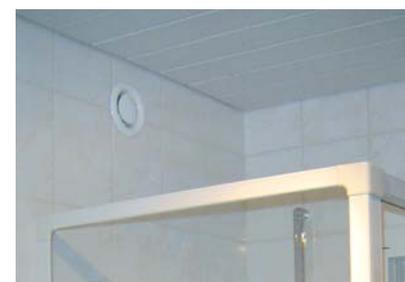
Exhaust valve for used air in a bathroom

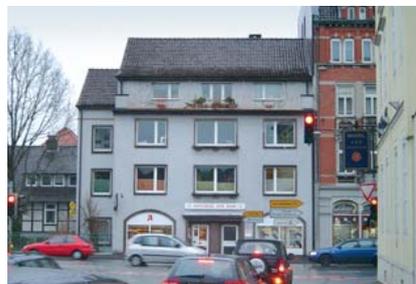
City house with bad conditions for ventilation via front windows

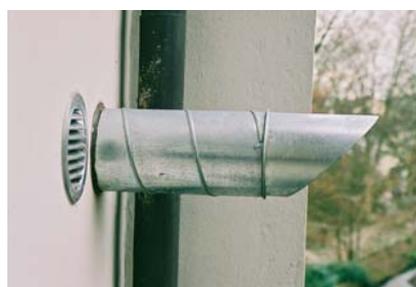
Fresh air supply is now from the garden side

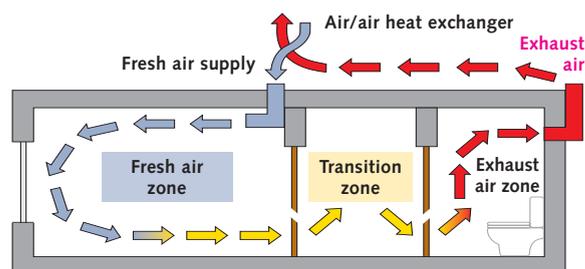
Simplified ventilation system

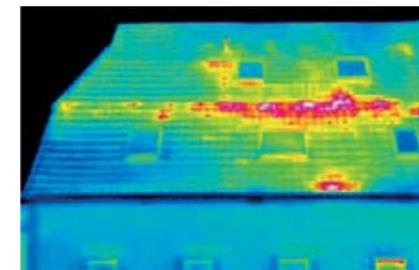
Heat losses through an air-leaky connection between lower and upper roof

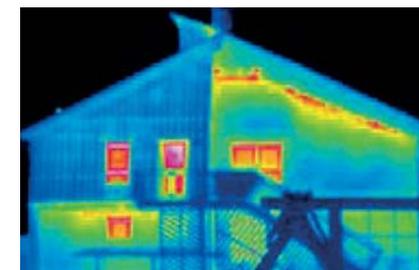
Heat losses through an air-leaky connection between front wall and roof

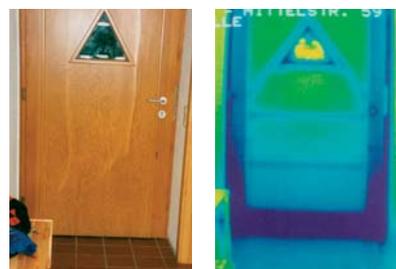
Cooling effect of an untight front door frame

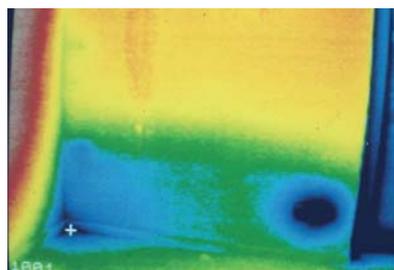
Cold area around the untight cable penetration of an outer wall

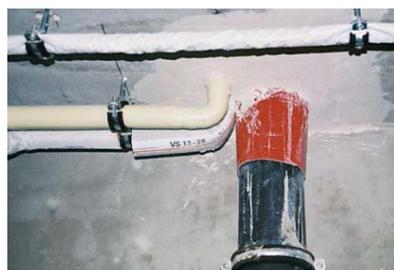
Well-sealed pipes crossing a cellar ceiling

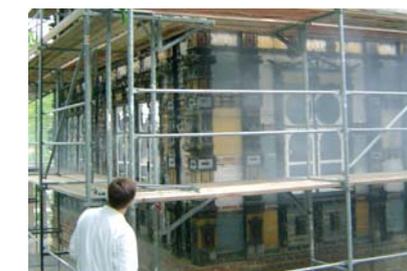
The outcoming smoke shows air leaks on a historical facade
